UTAH'S FLOOD PROBLEM

A Report to

UTAH STATE LAND BOARD

L. M. WINSOR  
Irrigation Engineer  
Bureau of Agricultural Engineering  
United States Department of Agriculture.

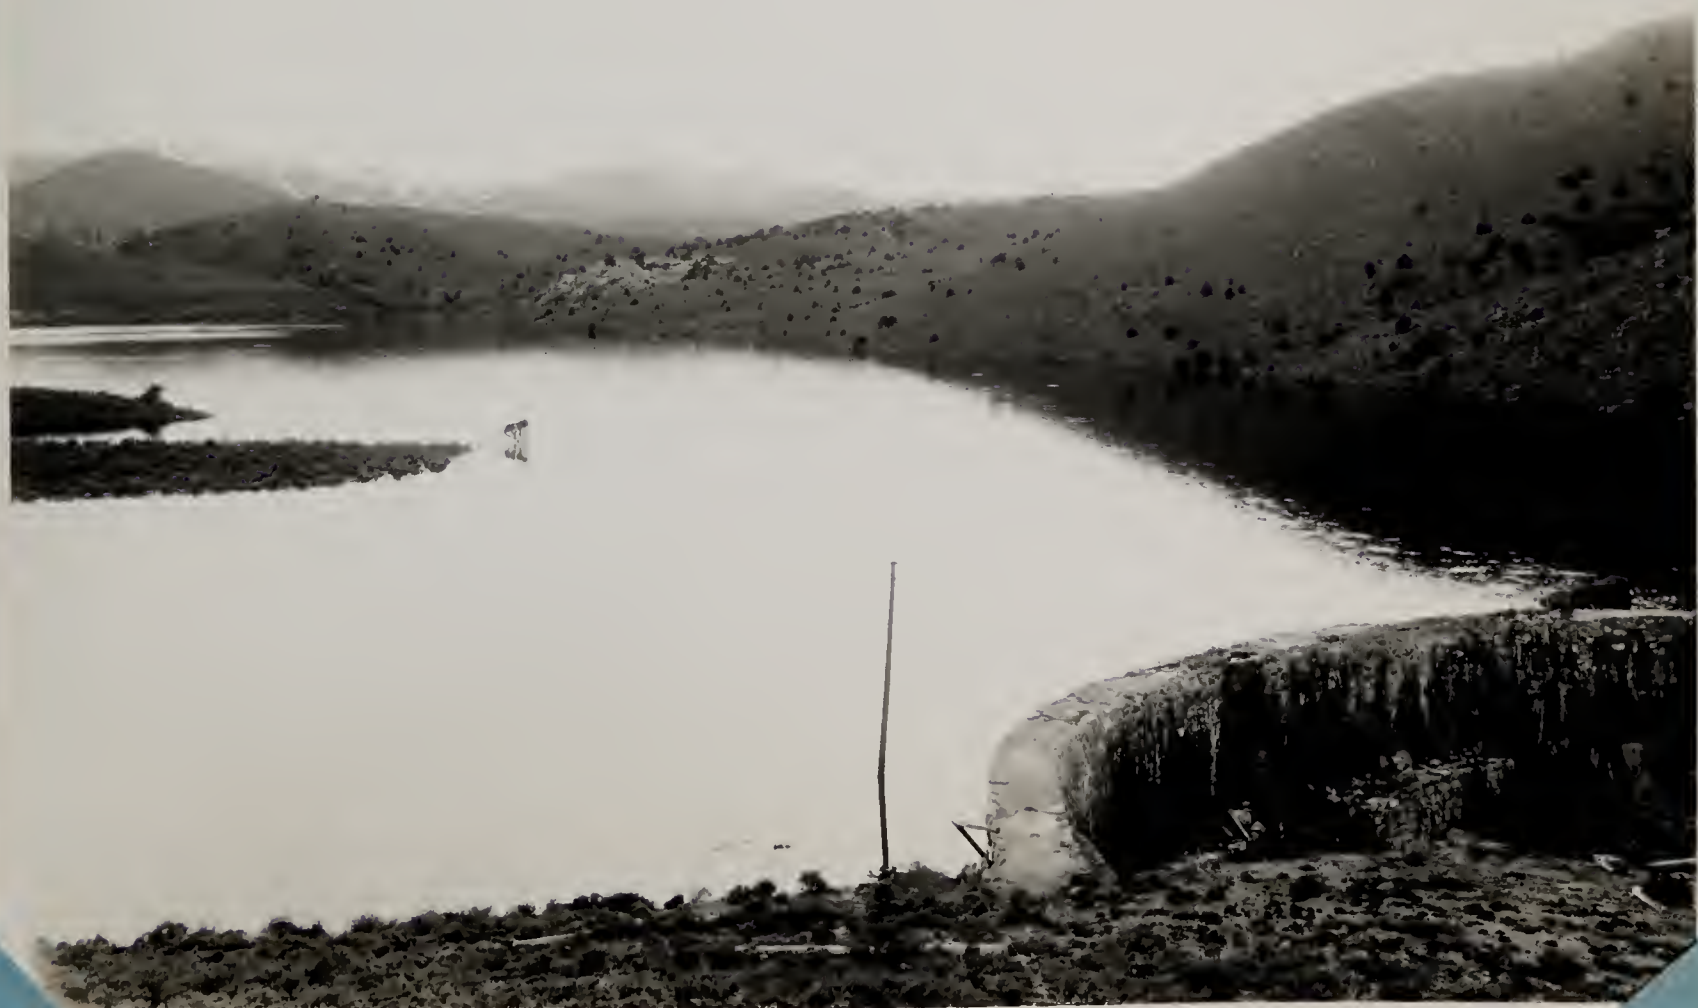
Equalizing Reservoir No. 2 on Shoal Creek. These Reservoirs built by Water Users with but little skilled help.

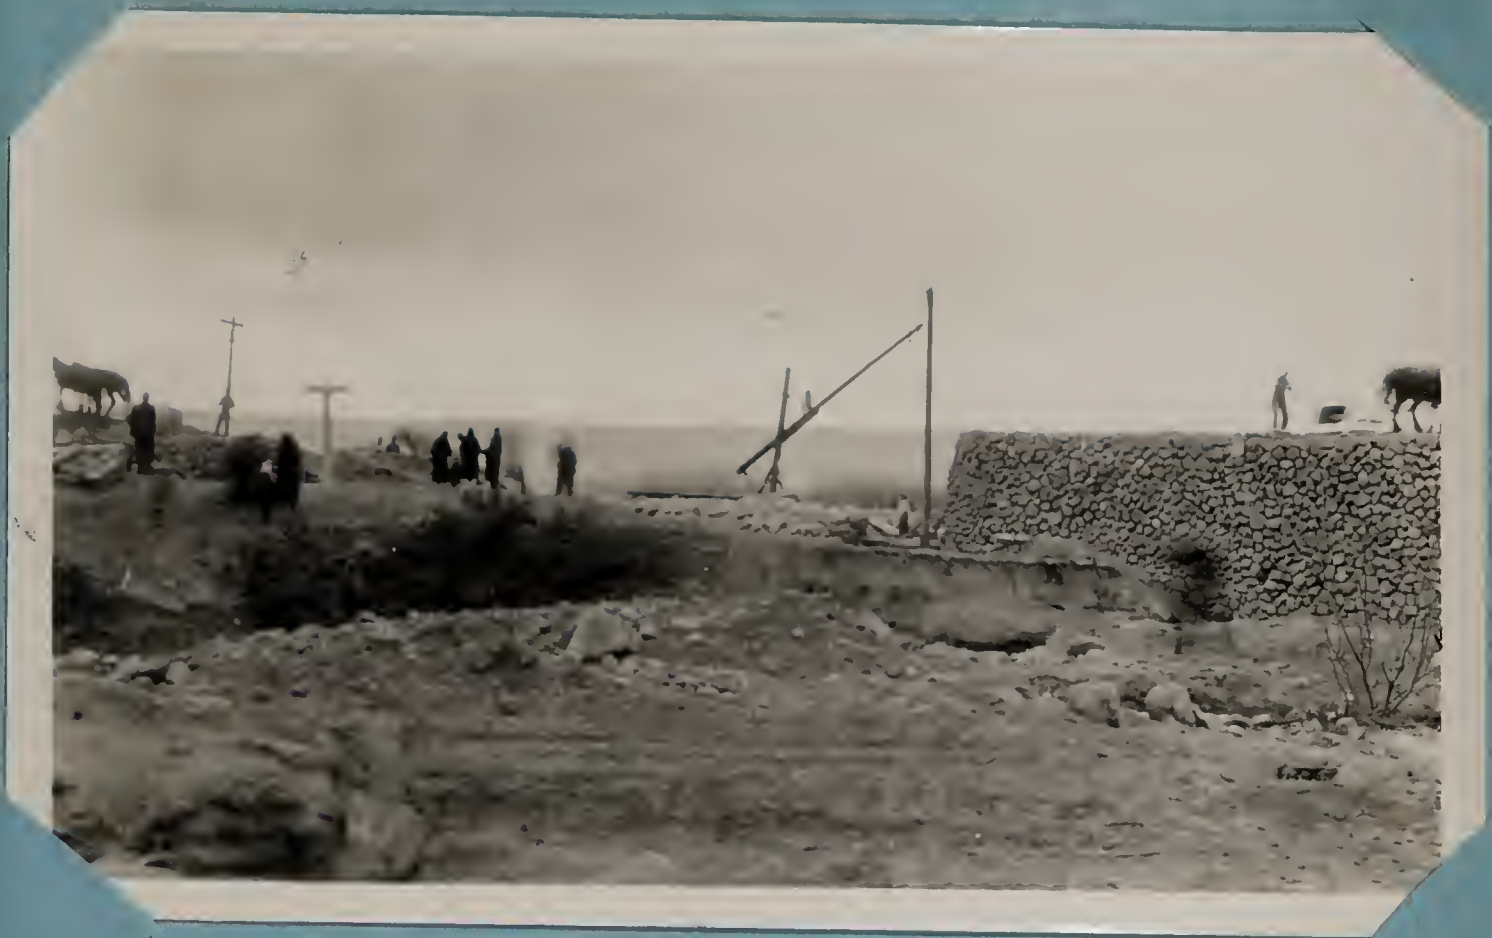
Mt. Pleasant Flood Barrier Spillway - Nearing completion November 11, 1928 - Looking downstream.

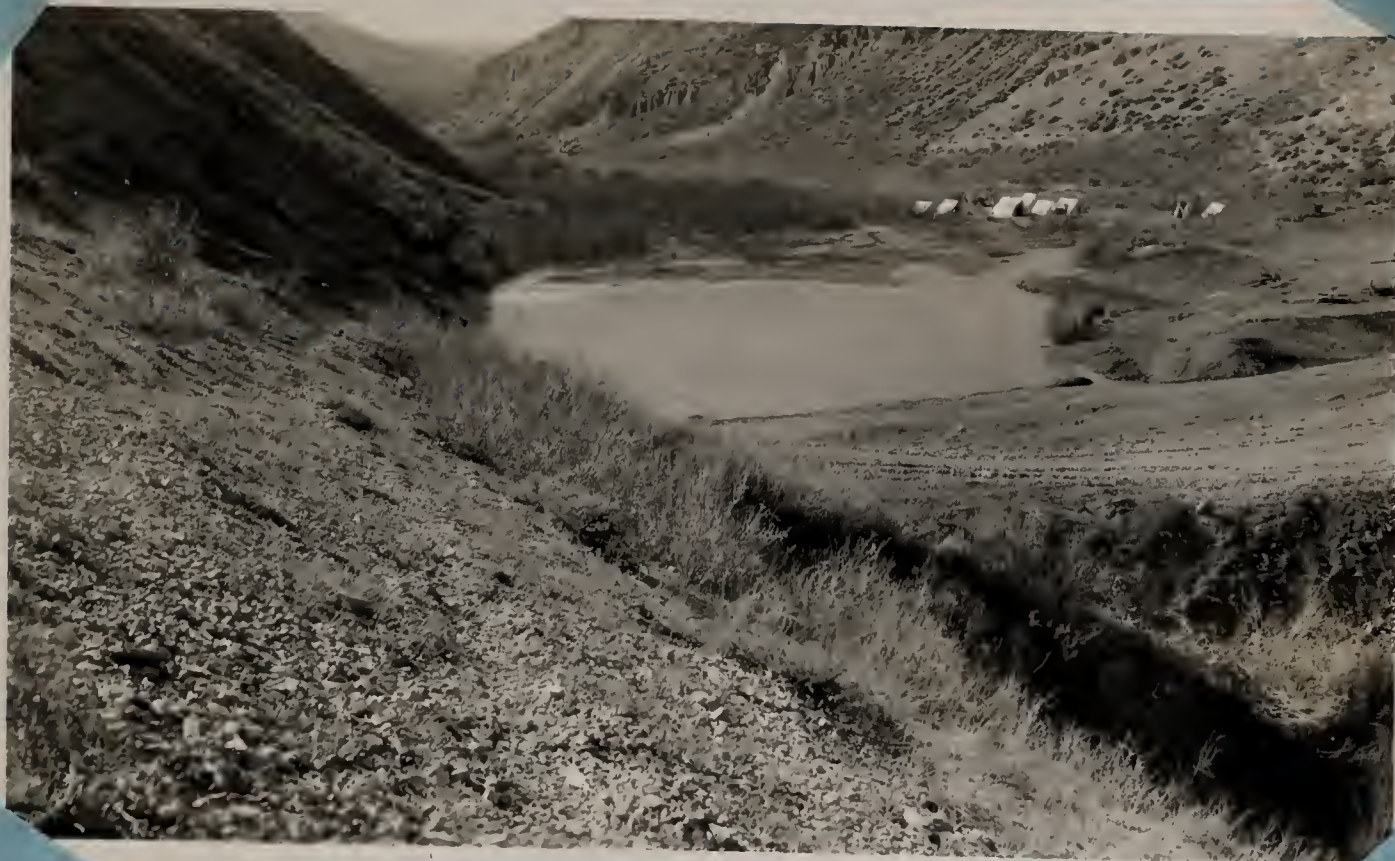
Woodruff equalizing reservoir, showing first construction camp, 1926, and beginning of the new dam. This structure is being raised at the rate of six to eight feet each fall. The spillway is a part of the dam and is made of rubble-concrete.

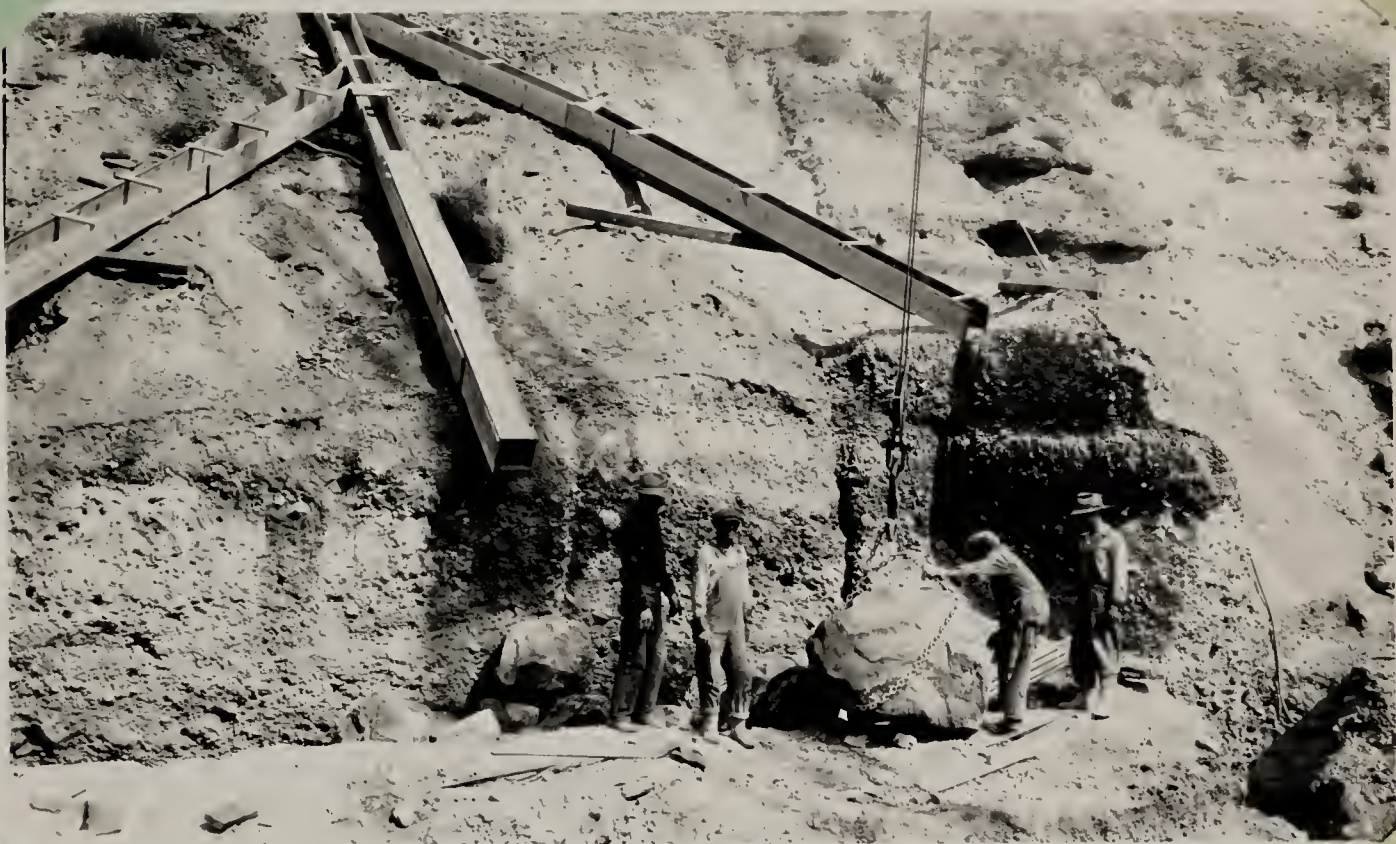
Boulders being placed by heavy derrick, in foundation of main spillway, Kessler Canyon.

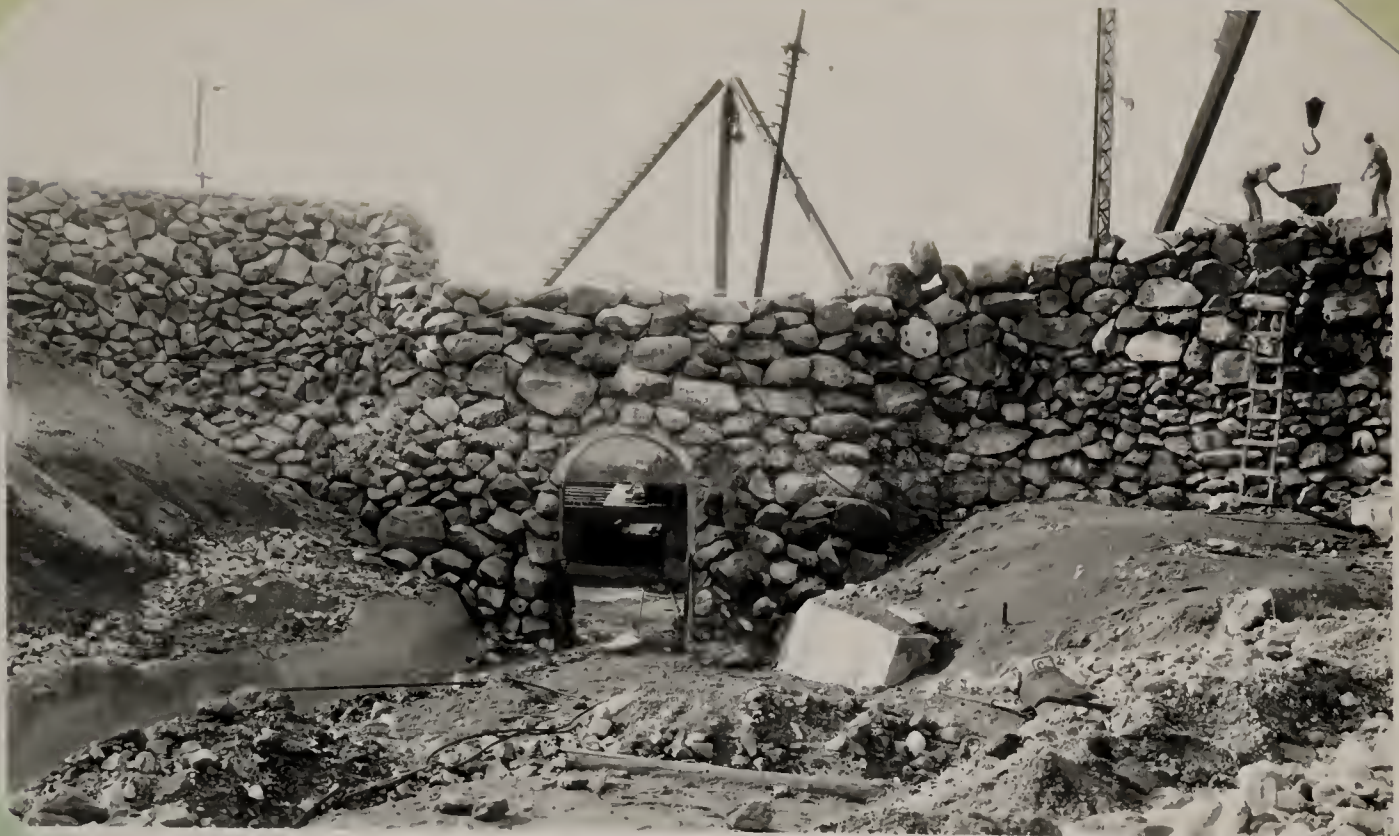
Building an equalizing check above intake to tunnel through Garfield Smelter. Note main tunnel opening in distance, which is same cross-sectional area as opening in foreground.

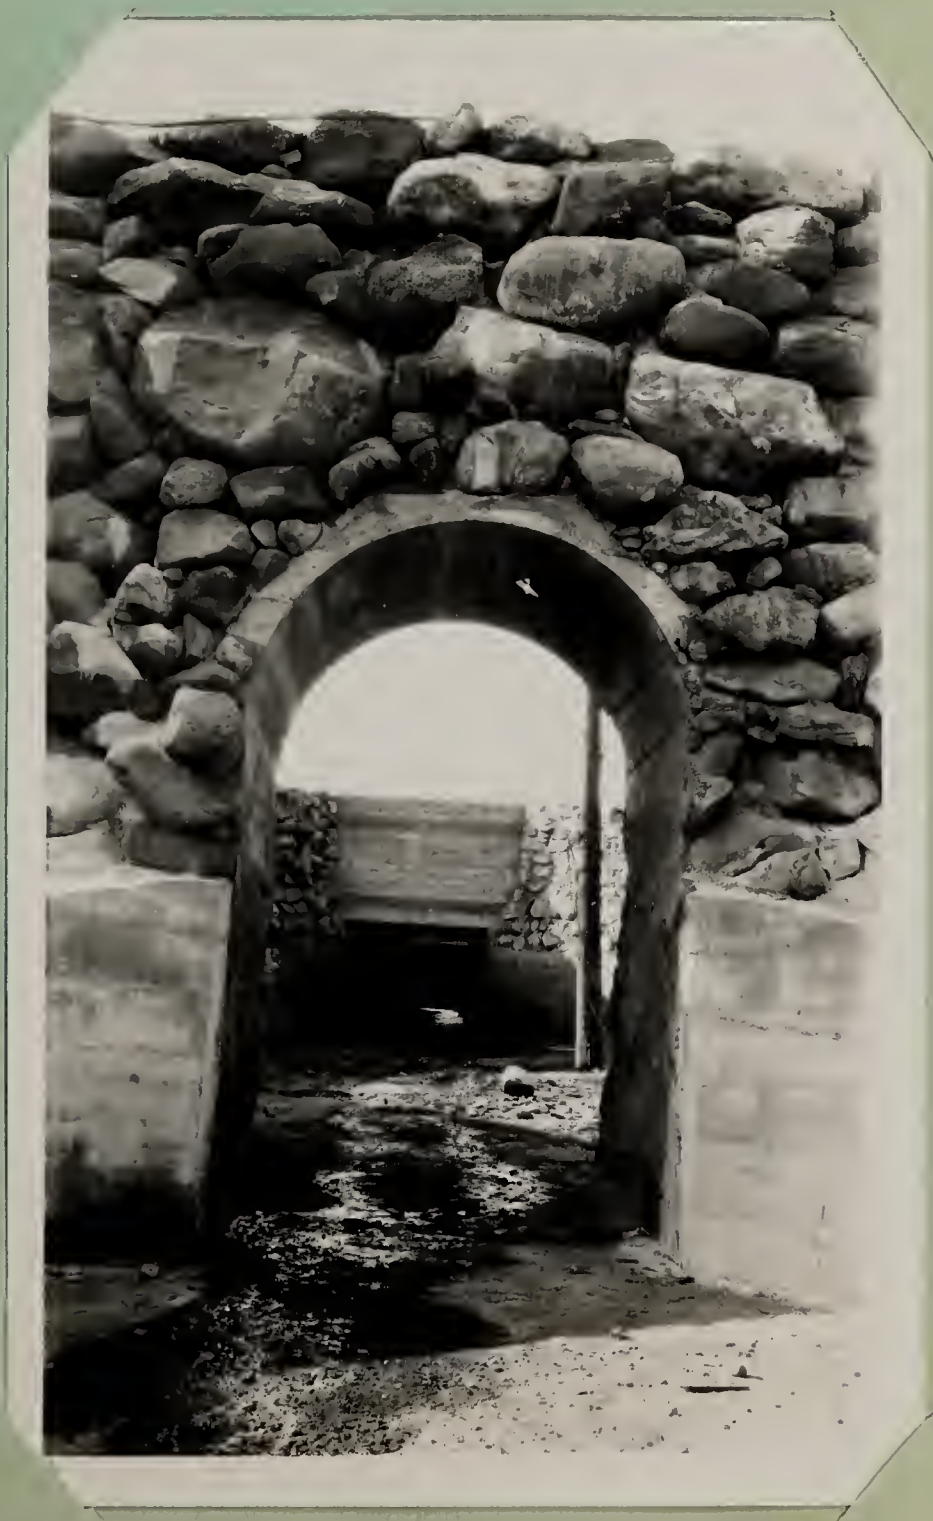
Detail of  
Rubble-Concrete  
Construction.  
Arch is 15 ft.  
high.

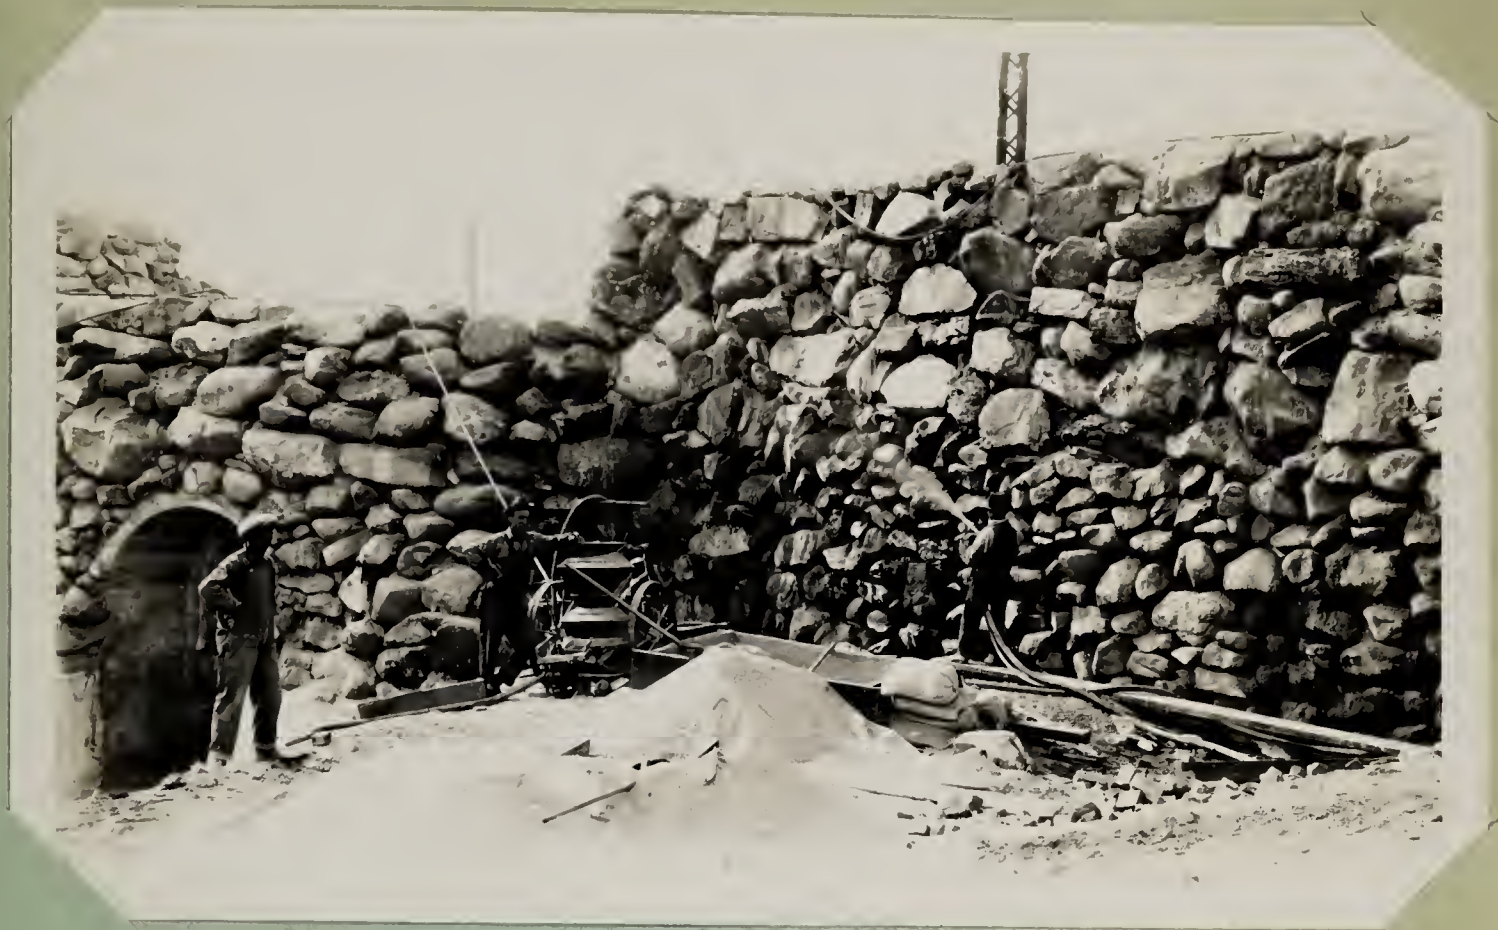
Guniting a Rubble-Concrete wing wall - Kessler Canyon

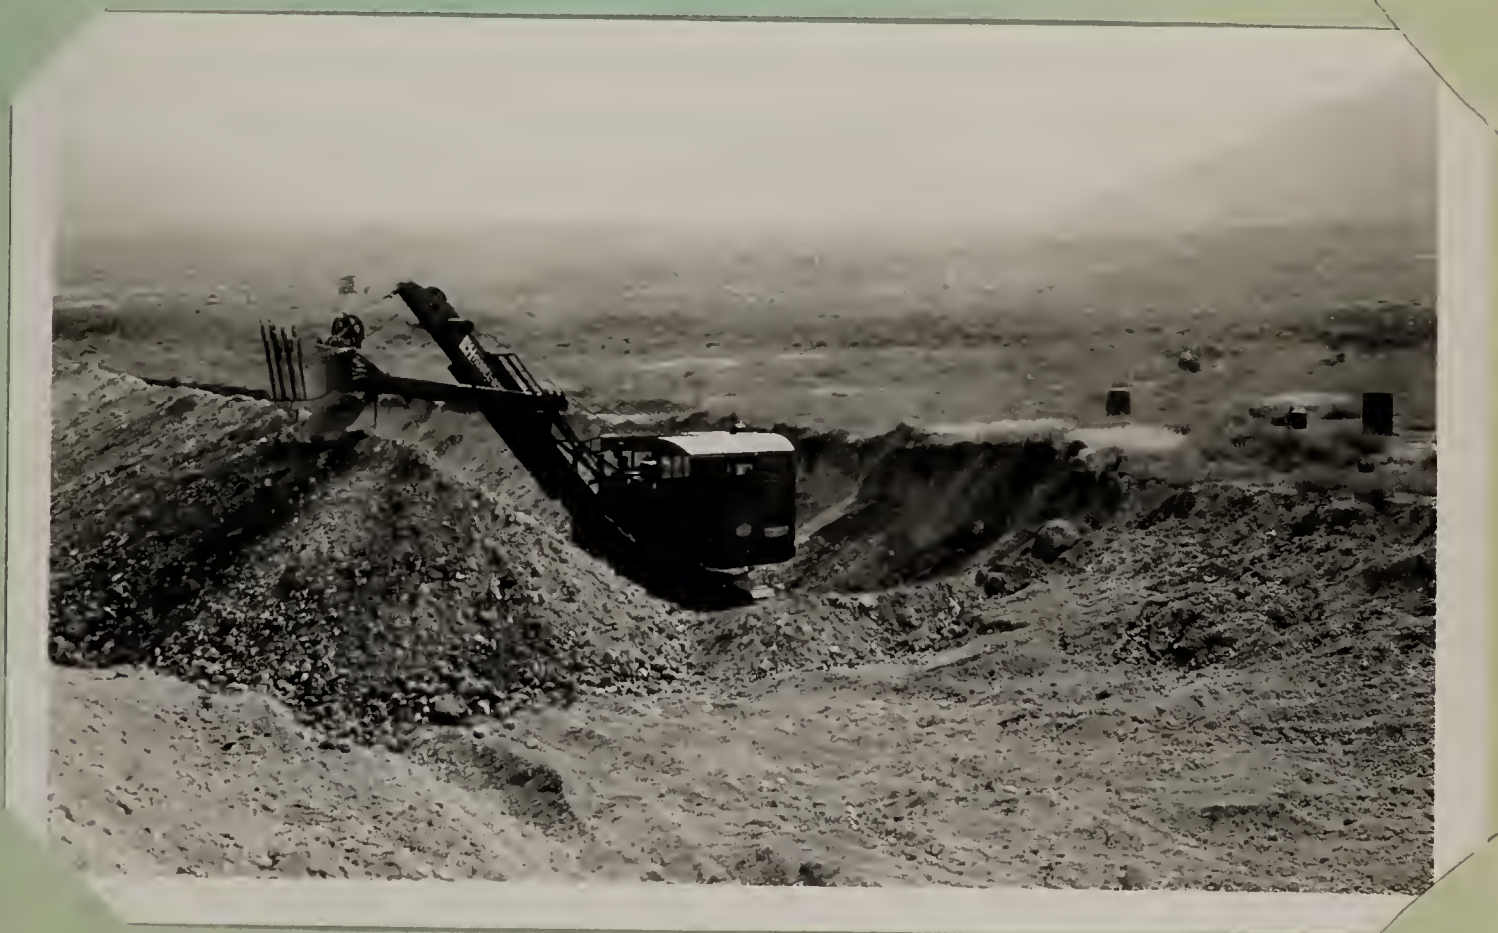
Gasoline driven shovel building the flood barrier, Kessler canyon. This dike was later raised 15 feet by tower dragline.

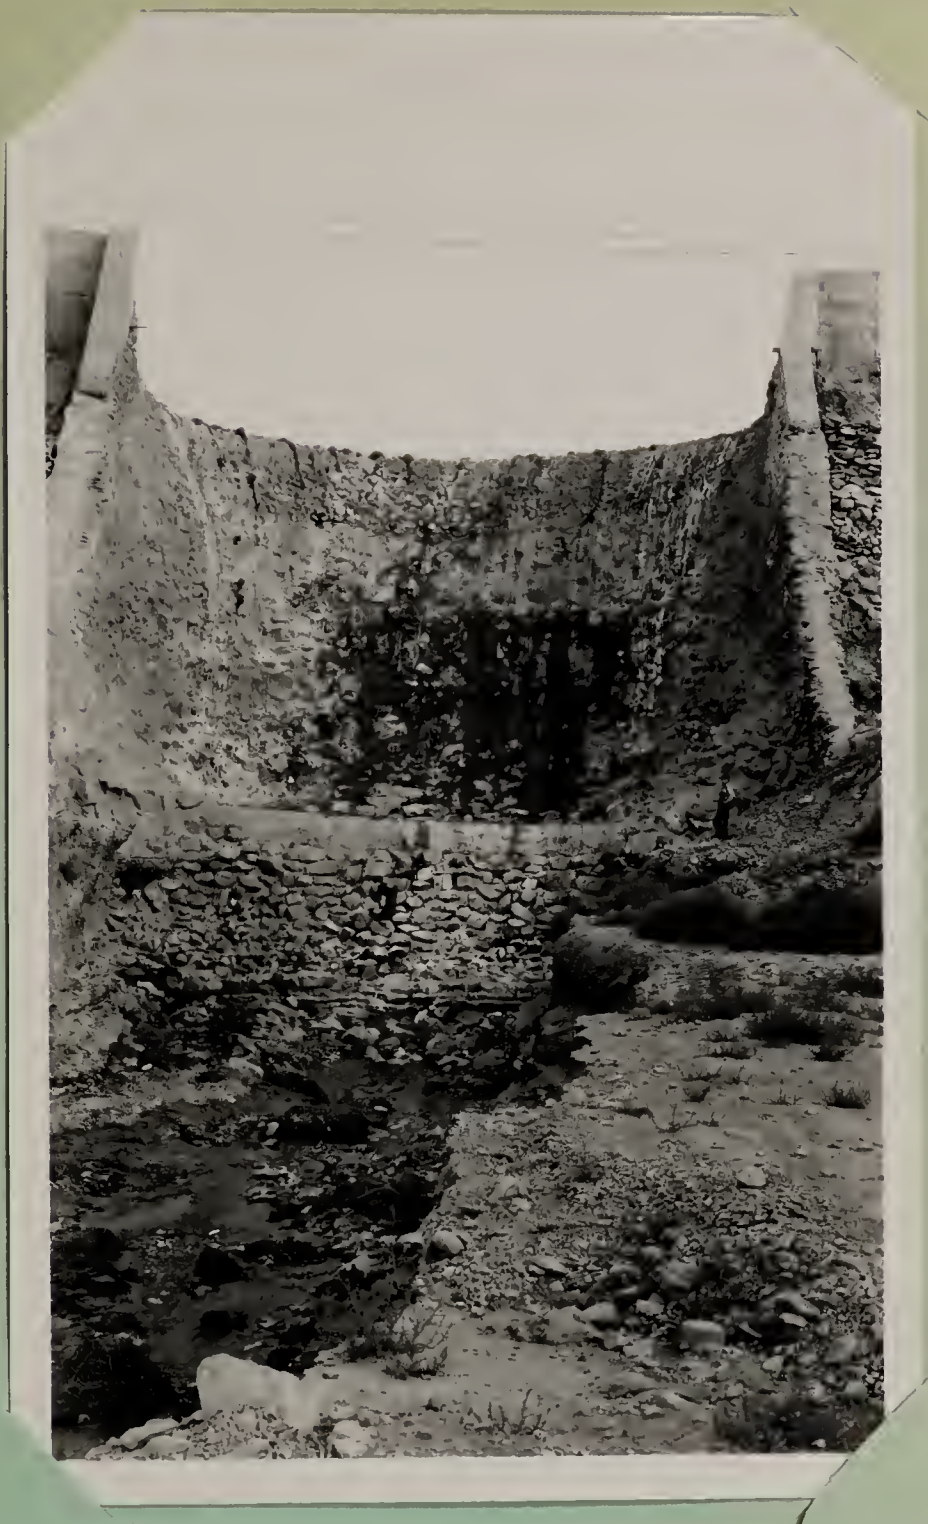
Spillway through main barrier, Kessler Canyon. This structure is a new departure in spillway construction. It stands 80 feet high and rests upon an alluvial foundation. Huge boulders, some of which weigh two or three tons, were placed in position then grouted together.

The flood stream drops over a circular crest into a stilling pool ten feet deep. A secondary crest below the stilling pool passes the stream quietly into the channel below.

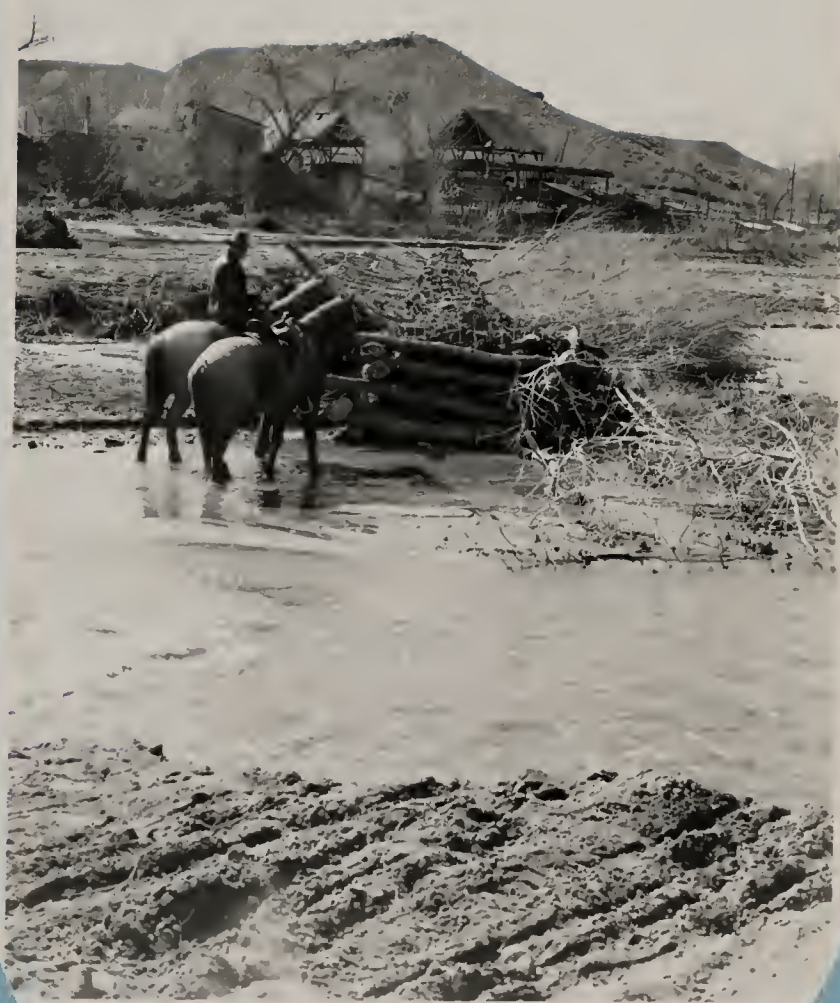
Flood breaker on Santa Clara  
Creek built during March, 1933.  
This is one of a series designed  
to hold the flood stream within a  
prescribed channel.

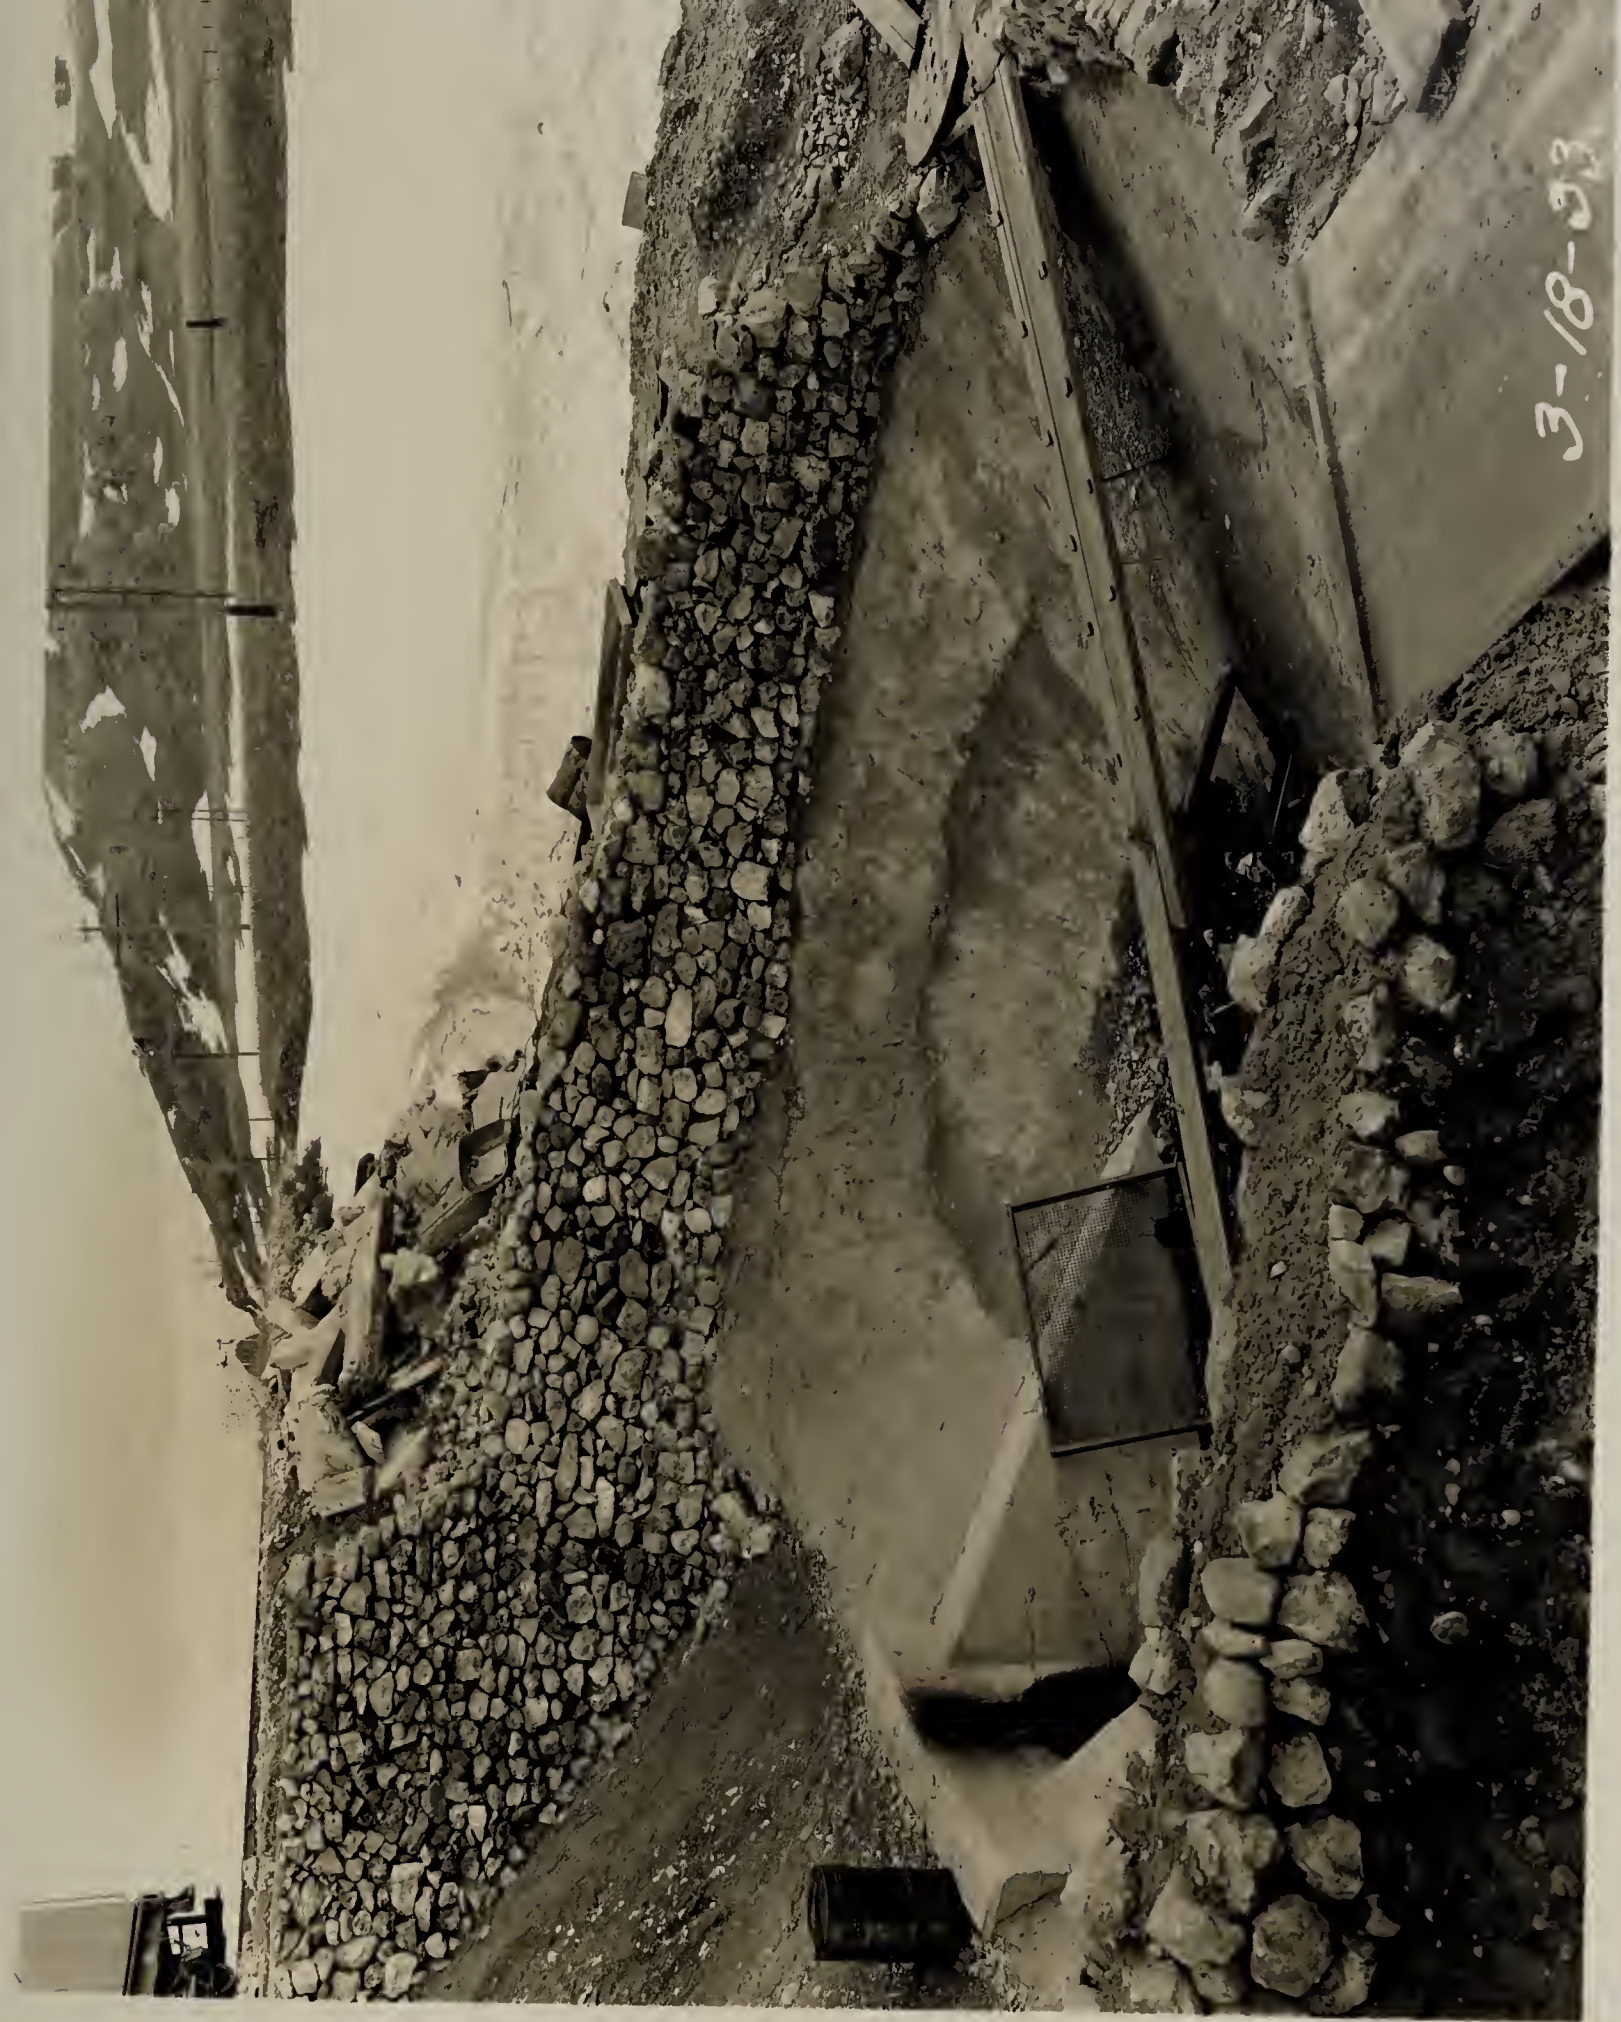
Flood Control Structure in process of construction at Magna, Utah. This is being built entirely by hand labor as an R.F.C. make work project.

View shows spillway above intake to tunnel beneath Bingham and Garfield Railroad, just south of Magna.
